# Manhole Inspection Summary

Manhole # S37Q\_\_012MH

Insp Date: **3/25/08 9:38 AM**

**Location** Address: **227 lois la**

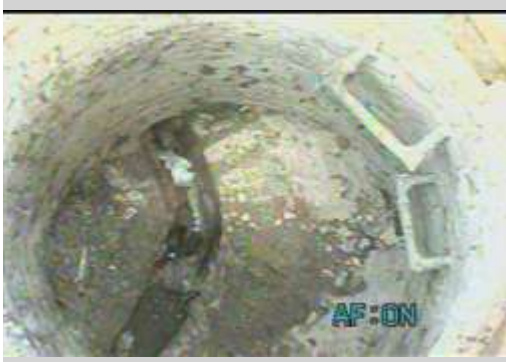
Defect 2

**Steps** Count: **2** Missing: **0** ☒ **Corroded**

Corroded Steps

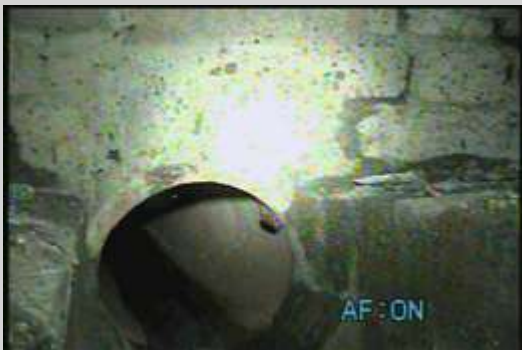
12 O'Clock Outflow

8 in. Circular Gravity Sewer  
Pipe Out @ 12 O'Clock

Deposits: ☒ None ☐ Mud ☐ Sludge ☐ **Debris** ☐ Grease

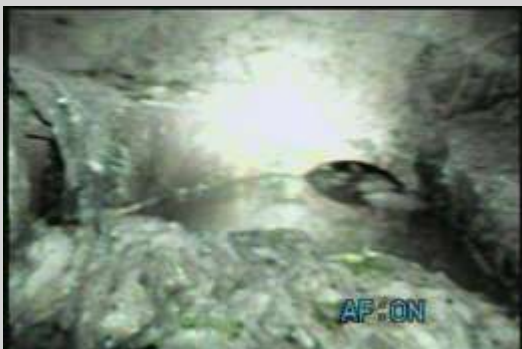
7 O'Clock Inflow

8 in. Circular Gravity Sewer  
Pipe In @ 7 O'Clock

Deposits: ☐ None ☐ Mud ☐ Sludge ☒ **Debris** ☐ Grease

Silt Depth: 6 (in.) Deposits Extent: **Heavy**
